**US Army Corps
of Engineers**

USACERL Technical Report 96/77
July 1996

Investigation of Preapproved Underground Heat Distribution Systems

by
Charles P. Marsh, Nicholas M. Demetroulis, and James V. Carnahan

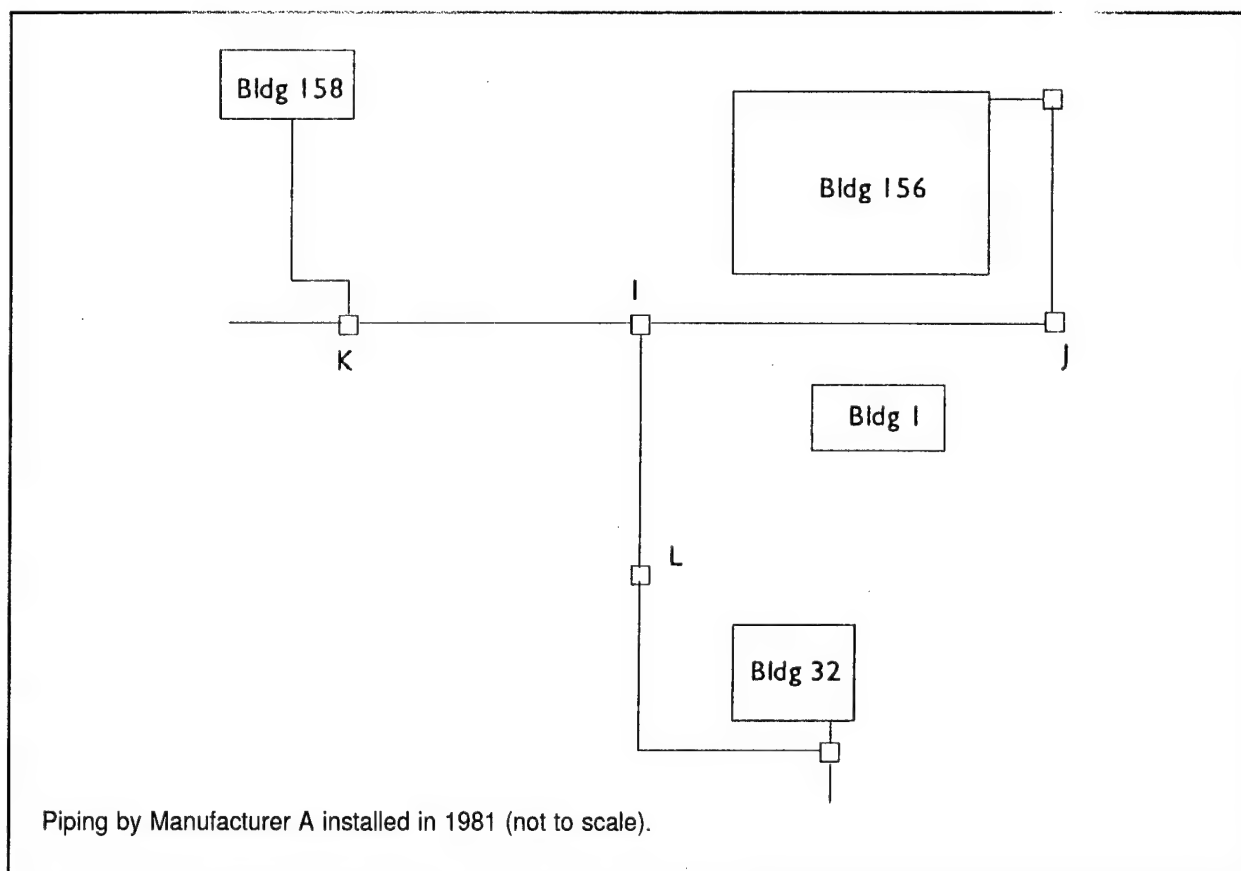
Figure M3. Schematic diagram of System 26 at Grissom AFB, IN.

(2) Pressure Test 2 (Condensate Return)—The condensate conduit casing was pressurized to 14.0 psi at 10:10 AM and exhibited no pressure loss through 10:40 AM, when the test was terminated.

b. Pressure Test 3—Conduits extended from Manhole I, described above, to Manhole K—a distance of 400 ft. Manhole K was 5 ft × 10 ft × 7 ft deep with an open grate top. Water was pumped out of the manhole after adjustment of the sump pump float mechanism. There was heavy water infiltration into the manhole at a conduit wall penetration. The 20-in.-diameter steam conduit casing contained a 10-in. steam pipe. The 12-in.-diameter condensate conduit casing contained a 4-in. return line.

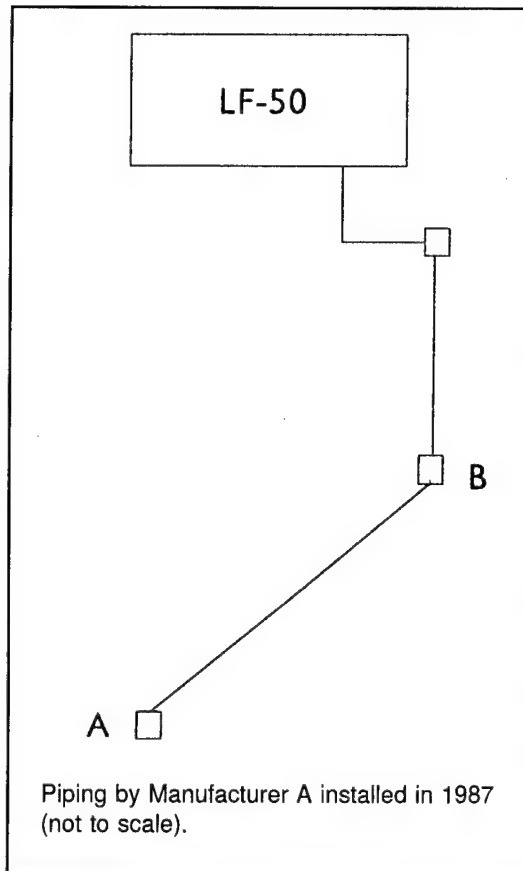
Figure N1. Schematic diagram of System 27 at Norfolk Naval Station, VA.

This system consists of piping from Manufacturer A and has a steel conduit (Figure N1). It was installed in 1987.

Pressure Test—This conduit section extended from Manhole A at the intersection of Toway and Avionics streets under Toway northward to Manhole B south of Building LF-50. The distance between manholes was 200 ft. Manhole A was in a parking area and was constructed of concrete with a solid concrete top flush with the pavement. The top contained 36-in.- and 24-in.-diameter access holes with steel plate covers. No manhole ventilation was provided. Manhole dimensions were 12 ft × 8 ft × 7 ft deep. A slight steam leak was present at the steam ejector sump pump. The heat carrying pipe had no insulation. Wall penetrations were caulked and cemented. Manhole B was concrete with walls extending about 1 ft above grade. The solid concrete top contained two access openings and two 6-in. vent pipes. Manhole dimensions were 9 ft × 12 ft × 8 ft deep.

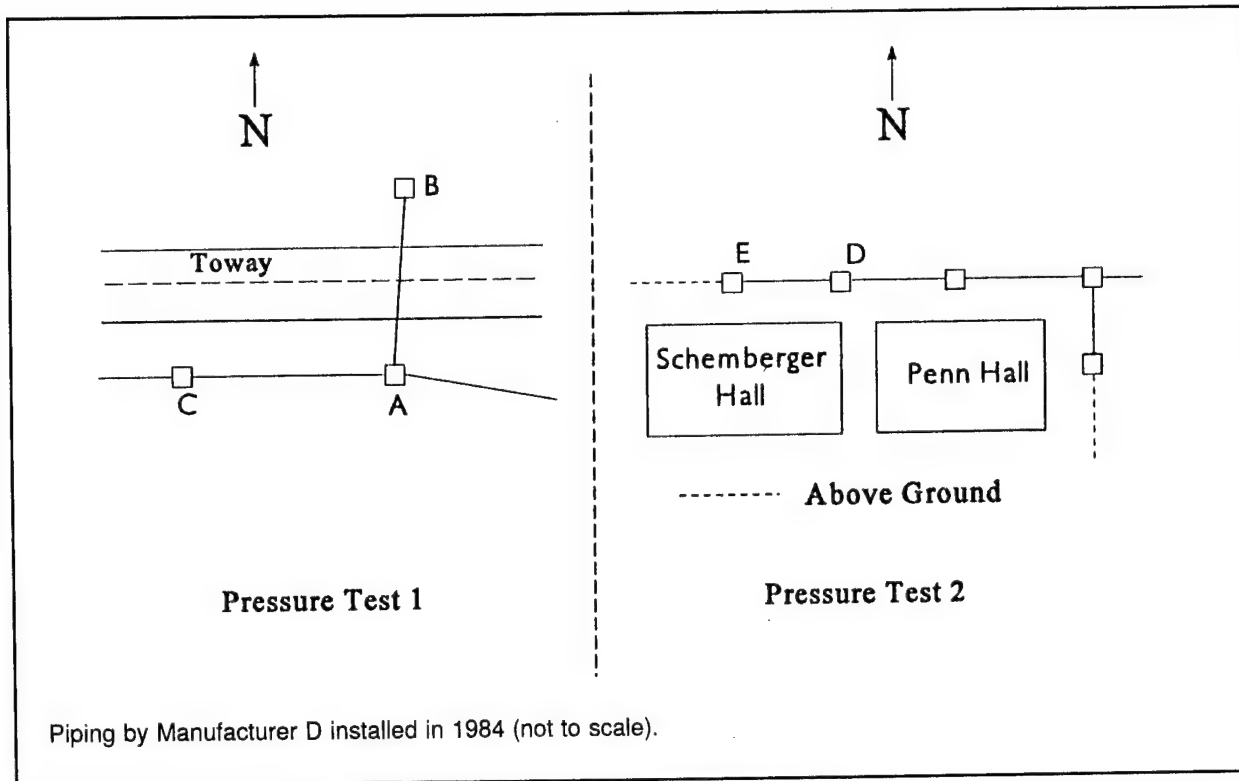
Figure N2. Schematic diagram of System 28 at Norfolk Naval Station, VA.

This system consists of piping from Manufacturer D and has a steel conduit (Figure N2). It was installed in 1984.

a. Pressure Test 1—This conduit section extended from Manhole A, described above, westward 170 ft to Manhole C. Manhole C was concrete with a concrete top flush with the parking lot pavement. The top had two access openings but no vent pipes. Manhole dimensions were 6 ft × 12 ft × 7 ft deep. Water was pumped out of this manhole and a portable fan was used to cool the manhole before entry. A gland seal was installed on the supply line at the manhole entry. The gland seal was tightened before pressure was applied to the conduit. One of the flanges on the dielectric flange assembly had been removed so the system was no longer electrically isolated. The conduit casing was 20-in. in diameter and contained a 12-in. steam line. Pressure to 15.0 psi was applied to the casing at 10:33 AM. Pressure readings were as follows:

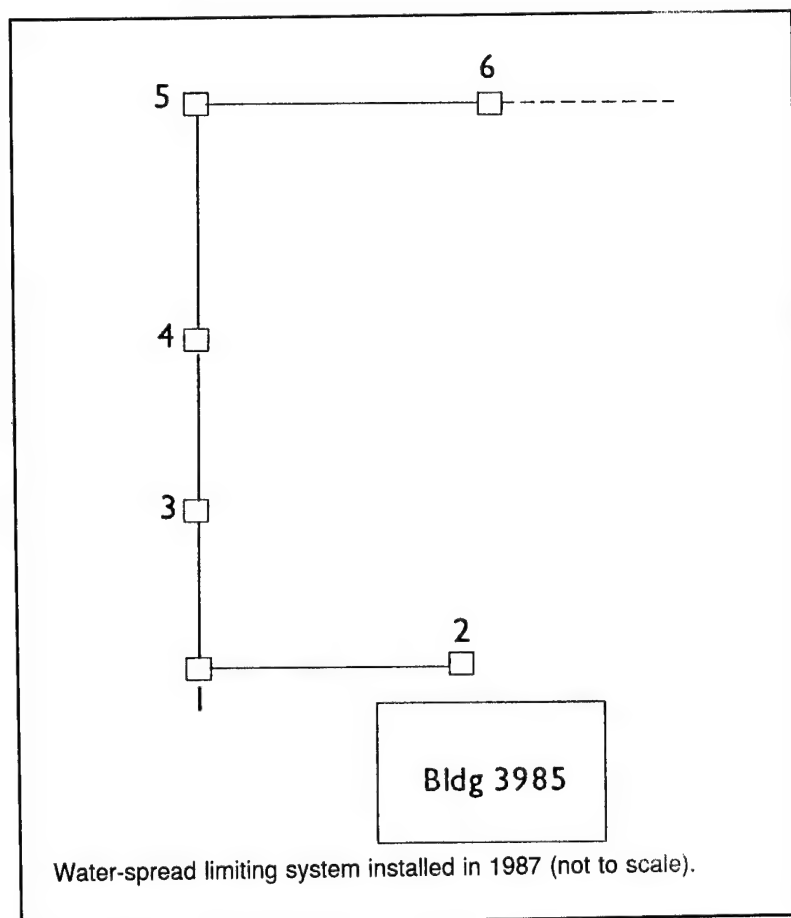
Figure O1. Schematic diagram of System 29 at Fort Lewis, WA.

d. Manhole 4—Located 300 ft north of Manhole 3, this manhole was buried 4 ft below grade and was accessed through a 30-in.-diameter tube extending from grade to the manhole top. Manhole dimensions were 6 ft × 8 ft × 7 ft deep. Manhole ventilation was provided by two 6-in. vent pipes. The manhole was dry and contained a sump and french drain.

e. Manhole 5—Located 600 ft north Manhole 4, this manhole was constructed of prefabricated concrete sections with concrete top at grade. Ventilation was provided by two 6-in. vent pipes. Manhole was dry and contained a sump and french drain. Manhole dimensions were 6 ft × 8 ft × 7 ft deep.

f. Manhole 6—Located 300 ft east of Manhole 5, this manhole was concrete with top at grade containing two 6-in. ventilation pipes. Manhole dimensions were 5 ft × 7 ft × 8 ft deep. The water-spread limiting system ended at this manhole with the conduit extending 2 ft into the manhole with no end seal. The manhole was dry with a gravity drain. Exit from this manhole was with a steel-cased conduit that continues to Manhole 7 located 100 ft east of Manhole 6. Manhole 7 provides for transition from buried conduit to concrete trench.

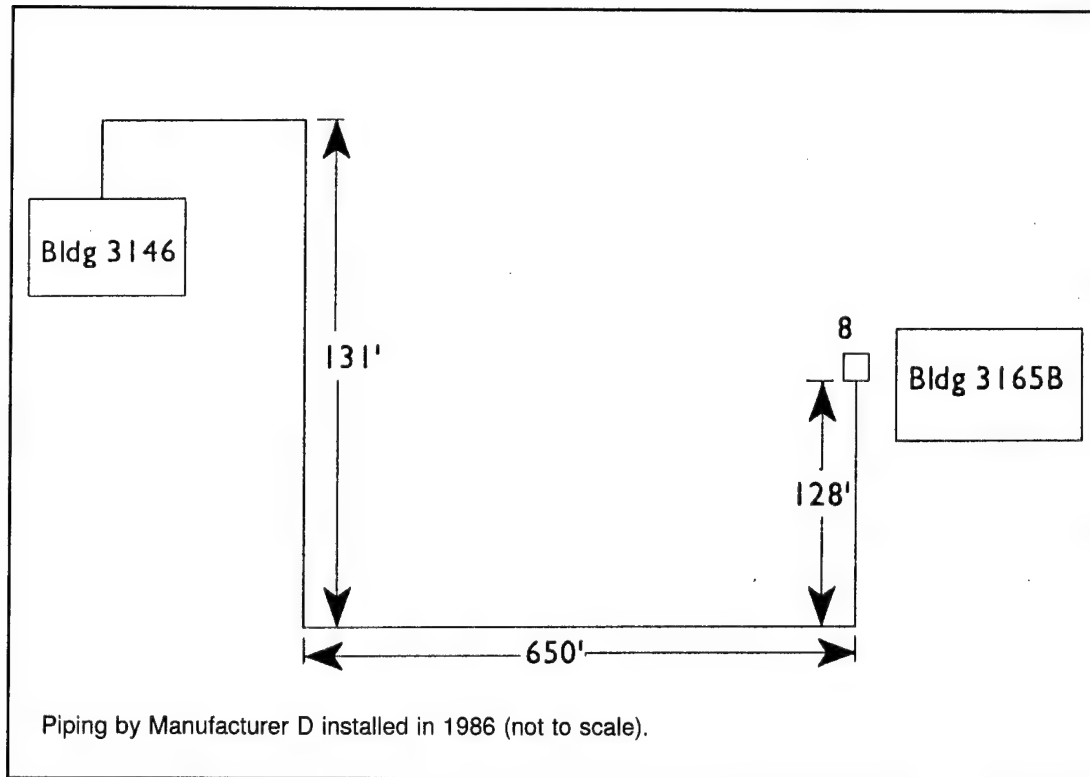
Figure O2. Schematic diagram of System 30 at Fort Lewis, WA.

This system consists of piping from Manufacturer D and has a steel conduit (Figure O2). It was installed in 1986. This section of conduit extended from Manhole 8 (just west of Bldg. 3165B) to the Special Forces Group Complex building. The length of this run was 1120 ft. Manhole 8 was concrete with top at grade containing a 30-in.-diameter access opening. The manhole had no vent piping. The conduit enters the manhole through the wall sleeve with caulking between the sleeve and the casing. Both the drain and vent openings at the end plate assembly were plugged. The

conduit rose through the floor at the equipment room of Bldg. 3146, terminating with a standard end plate. Both vent and drain openings at the end plate were also plugged, which sealed the conduit run.

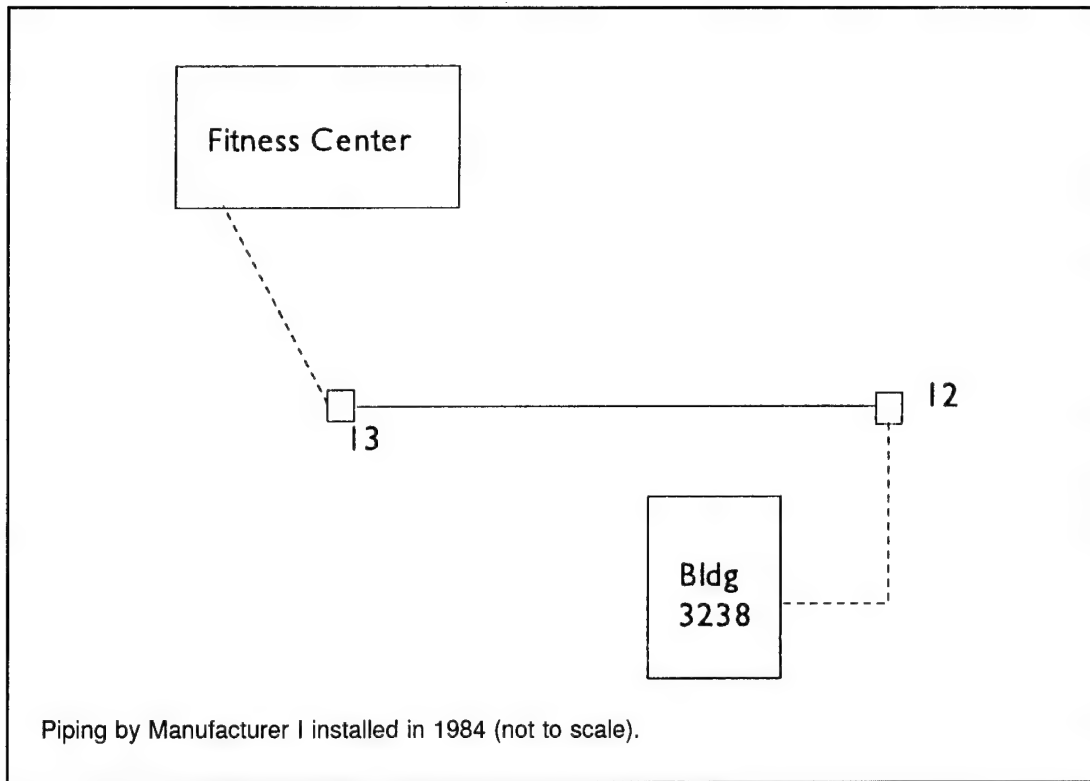
Figure O4. Schematic diagram of System 32 at Fort Lewis, WA.

(1) Manhole 12—This manhole was north of Bldg. 3238 and was concrete with concrete top at grade and dimensions of 7 ft x 7 ft x 8 ft deep. Manhole ventilation was provided by two capped 6-in. vent pipes. The manhole was dry at the time of inspection, and conduit wall penetrations were caulked and cemented. Access was through a 30-in.-diameter opening with a steel manhole cover.

(2) Manhole 13—This manhole was 500 ft west of Manhole 12. Construction was concrete with concrete top at grade containing a 3-ft square access opening with solid aluminum cover. Ventilation is provided by two capped 6-in. vent pipes. The manhole was dry at the time of inspection, and conduit wall penetrations were caulked and cemented.

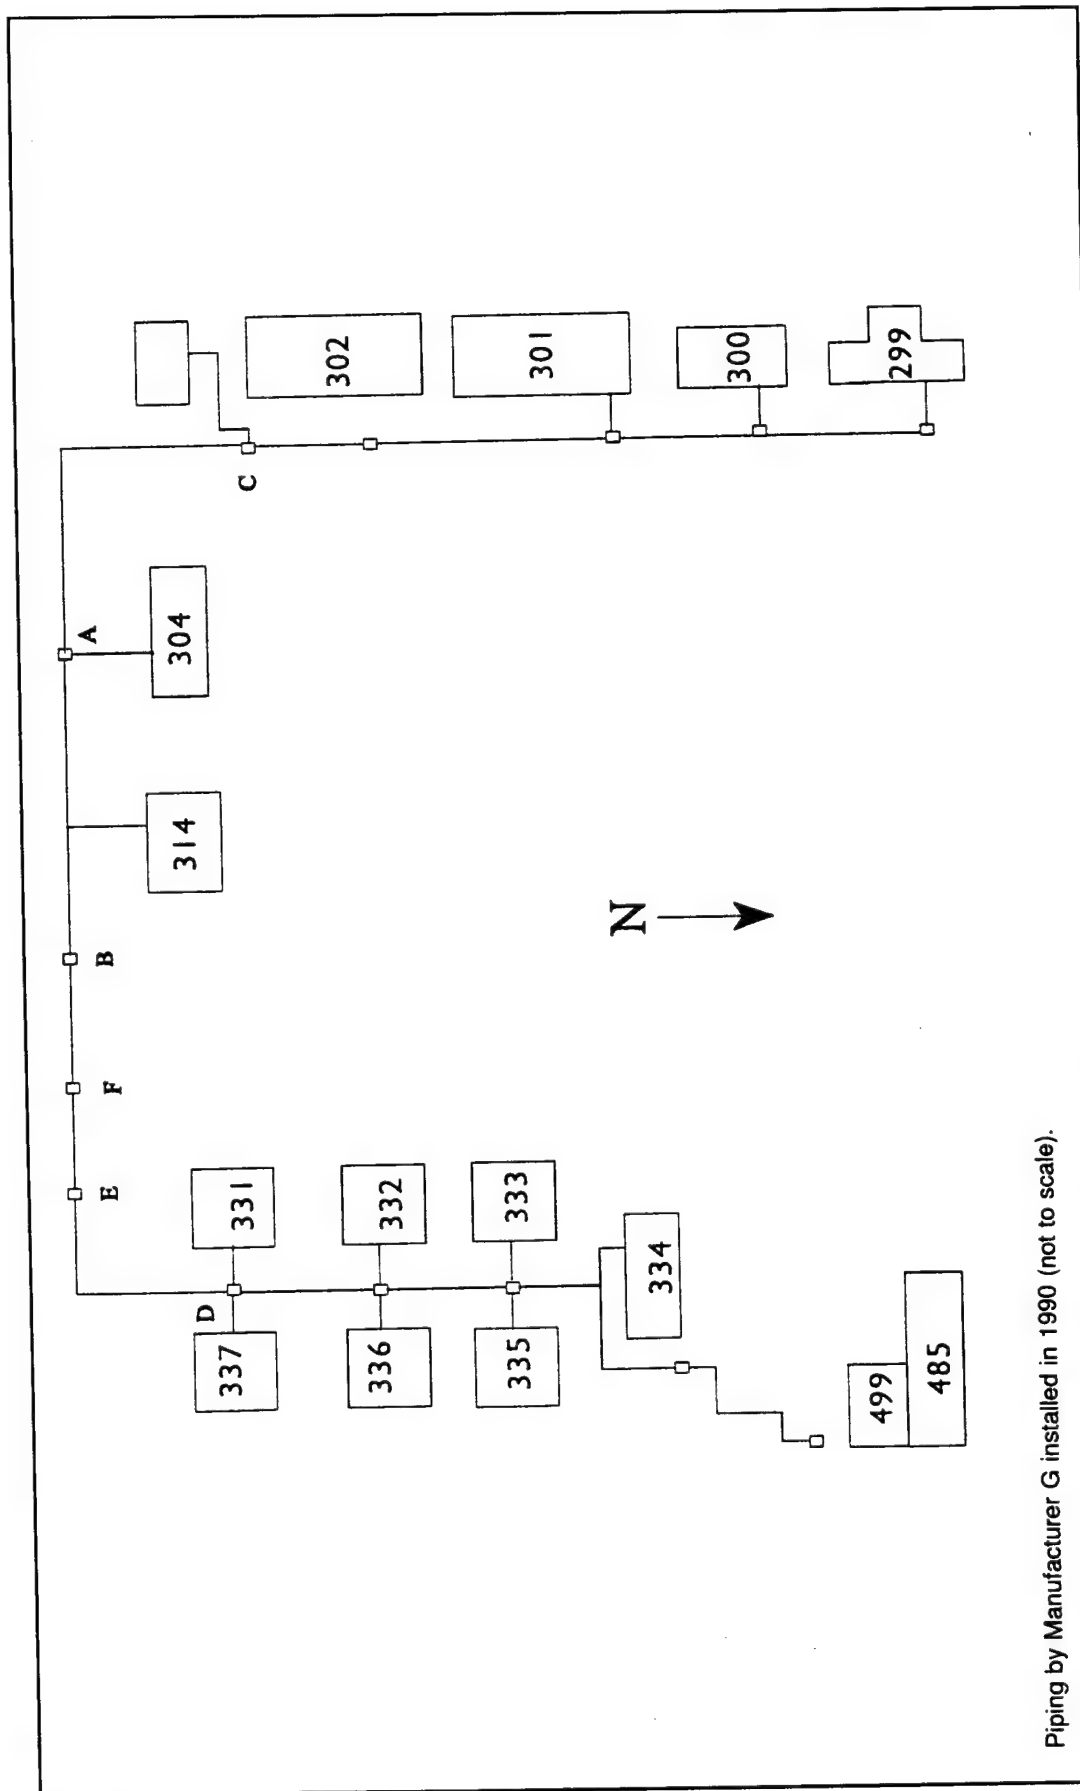
Figure P1. Schematic diagram of System 34 at San Diego Naval Training Center, CA.

10:00 AM — 15.0 psi
 10:05 AM — 7.5 psi
 (Leak at vent - Repressurized)
 10:23 AM — 15.0 psi
 10:28 AM — 12.0 psi
 10:33 AM — 9.5 psi
 10:38 AM — 7.7 psi
 10:43 AM — 6.2 psi
 10:53 AM — 3.7 psi

b. Pressure tests - Manhole A to Manhole B—Conduits ran 500 ft east from Manhole A to Manhole B. An underground take-off between the manholes extends to risers outside the building. Manhole B is concrete with concrete top at grade.

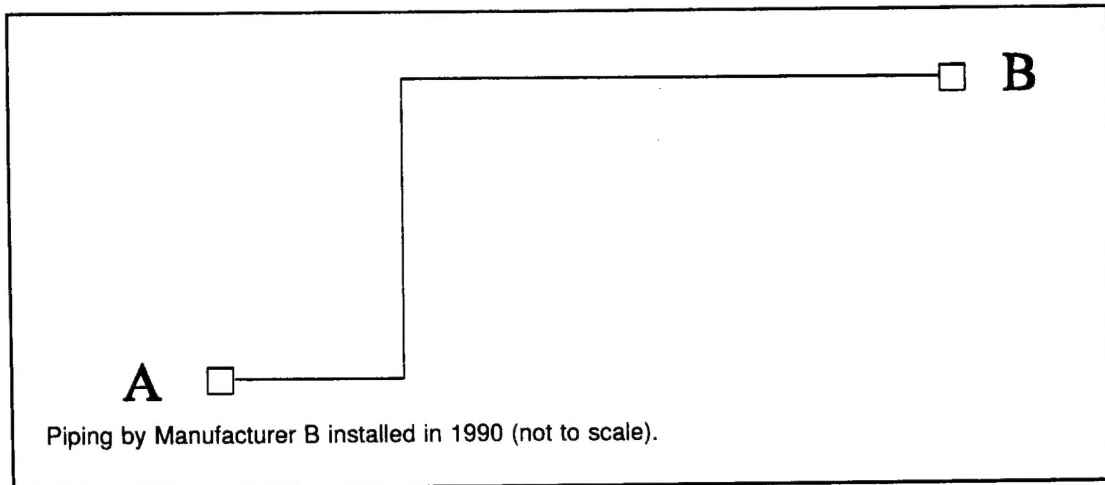
Figure P2. Schematic diagram of System 35 at San Diego Naval Station, CA.

Manhole B was in the street and the top contained two 36-in. slotted manhole covers that provide both access and ventilation. The manhole was concrete, and the dimensions are 18 ft × 12 ft × 7 ft deep. The manhole was dry and was served by a steam jet sump pump. The wall penetration was the same as in Manhole A described above. The conduit end plate was standard with no gland seal.

Pressure was applied to the casing at 1:25 PM, and it slowly rose to 3 psi but would not rise further. The gland seal and gauge and compressor connections were thoroughly checked for leakage and were found to be sound. The compressor was operated for an additional 50 minutes, but no additional increase in pressure was evident. When the conduit casing was sealed by valving off the compressor, the pressure immediately dropped to zero.
